[Docket No. FAA-2016-9418; Directorate Identifier 2016-NE-23-AD]

Airworthiness Directives; Honeywell International Inc. Turboprop and Turboshaft Engines

ACTION: Notice of proposed rulemaking (NPRM).

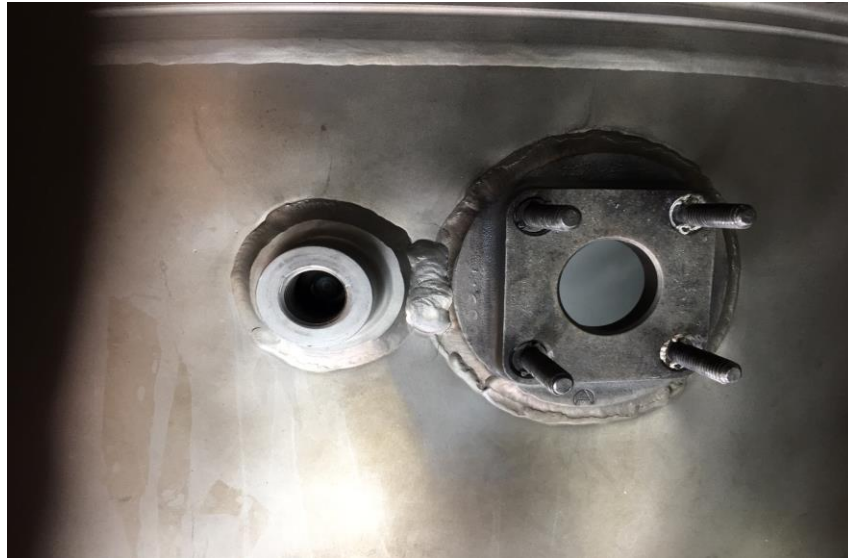
Figure 1 to Paragraph (g) of this AD. Combustion Chamber Case Assembly

(2) Figures 1 and 2 to paragraph (g) of this AD illustrate the appearance of combustion chamber case assembly, P/N 893973-5, without and with, respectively, the one-piece bleed pad with the P3 boss.

Without the One-Piece Bleed Pad with P3 Boss

(2) For TPE331-3U, -3UW, -5, -5A, -5AB, -5B, -6, -6A engines with combustion chamber case assemblies, part numbers (P/Ns) 869728-1, 869728-3, or 893973-5, installed, and without the one-piece bleed pad with P3 boss, and for TPE331-1, -2, and -2UA engines modified with increased P3 pressures, including, but not limited to, engines modified by supplemental type certificate (STC) SE383CH, remove the combustion chamber case assembly from service at the next removal of the combustion chamber case from the engine.

After the effective date of this AD, do not install a combustion chamber case assembly, P/N 869728-1, 869728-3, or 893973-5, in an engine, unless the combustion chamber case assembly has a one-piece bleed pad with P3 boss.
